DEVELOPMENT OF A SPECIAL MACROSEISMIC SCALE BASED ON THE DATA OF CHURCHES DAMAGED BY THE 1926 LENINAKAN EARTHQUAKE

Tataryan V. H.

Territorial Survey for seismic protection of the Ministry of Emergency Situations of Republic of Armenia

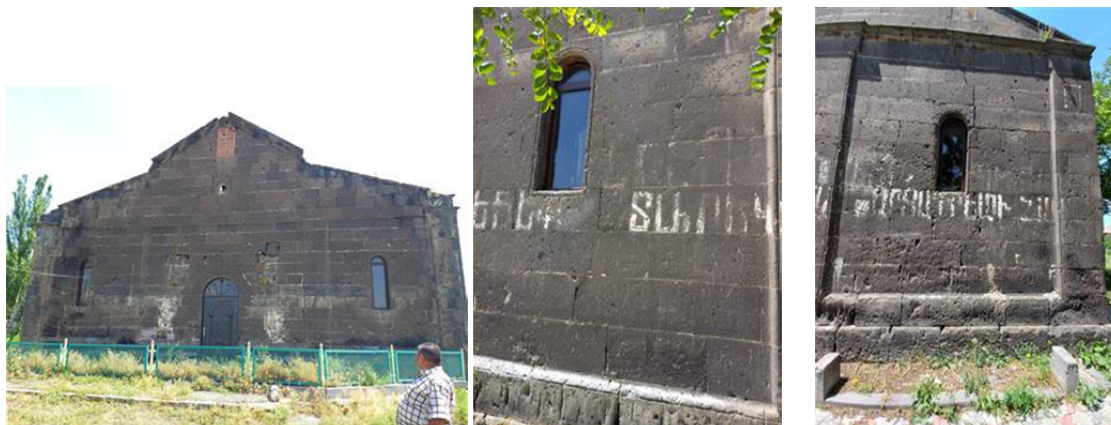
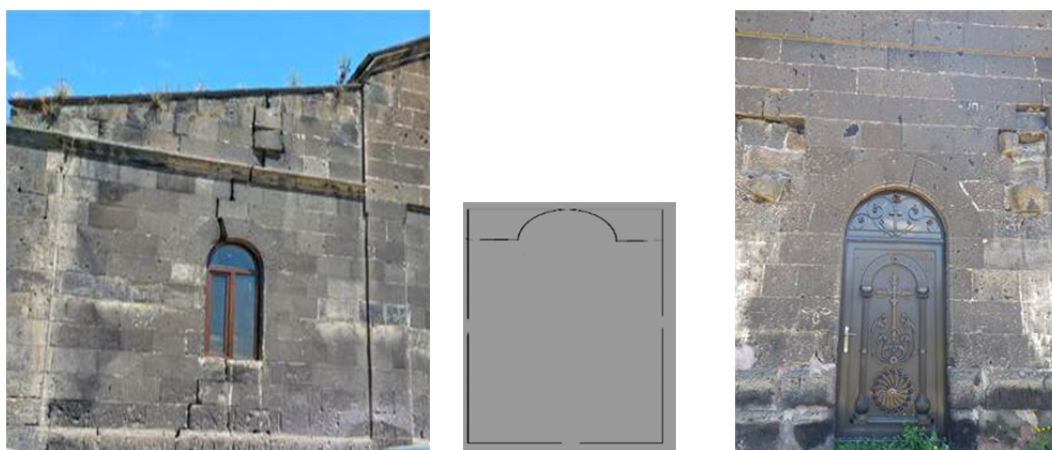
Church St. Mary, v. Gusanagjukh

- All walls have cracks as well as hairline cracks.
- 3 cracks on 3 walls in the western part, 2 cracks (not wide) on the eastern wall.
- 3 cracks along the entire height of the wall.
- The dome was damaged by the 1926 earthquake and demolished in 1933.
- The bell tower built later was demolished due to lack of connection with the building.
