REGULARITIES OF MUDFLOWS AND FLOODS FORMATION IN ARMENIA

Boynagryan V.R.

Yerevan State University, Yerevan, Armenia
vboynagryan@ysu.am

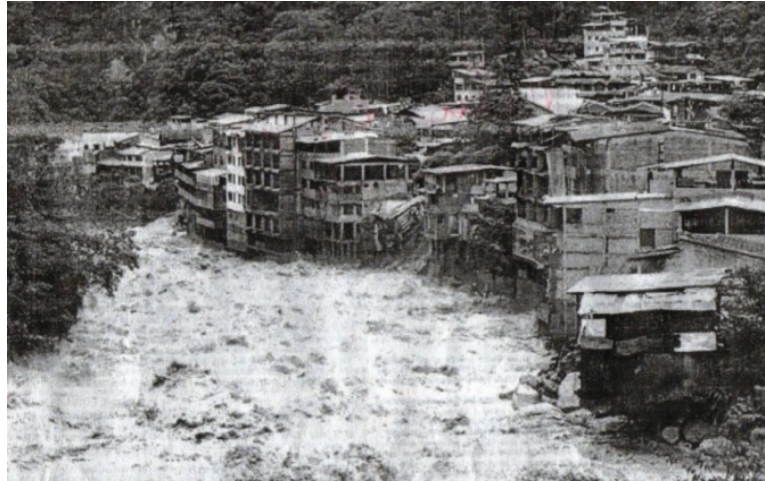
The Getar River originates from the western slope of the Gegham volcanic massif, known for its mudflow activity and especially for the catastrophic mudflow of 1946, which caused significant damage to the Armenian capital Yerevan. A mudflow wave with a height of 4.9 m brought blocks up to 1.5-3.0 m in diameter to Yerevan, and the volume of the mudflow exceeded 1 million m³. Houses and bridges were destroyed; mud-stone mass flooded gardens and vegetable gardens (see Fig. 1).

Fig. 1. Mudflow of 1946 in Yerevan.

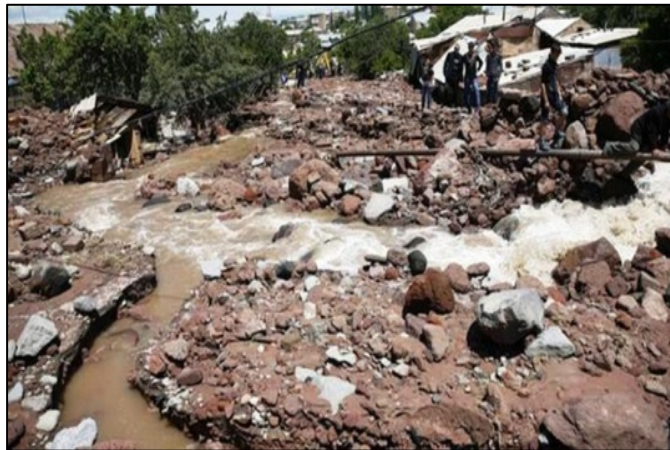
In June 2016, after heavy rain with hail in the vicinity of the Aragats volcanic massif (50-60 mm of precipitation fell in an hour) and intense snow melting on the slopes of Aragats, large masses of water rushed along the bed of the Garangu River to Artik, where they overflowed their banks and, forming a new channel, flowed right through the streets of the city among houses and vegetable gardens (see Fig. 2 - 3). Why did this become possible? Usually, the water along the Garangu riverbed flows in a thin trickle only in autumn and spring, the rest of the time the riverbed is used by the local population as a garbage dump, illegal vegetable gardens (even chernozem was brought), as well as for the construction of cowsheds and even residential buildings!

Fig. 2. Mudslides of the river Garangu in the Article – June 24, 20

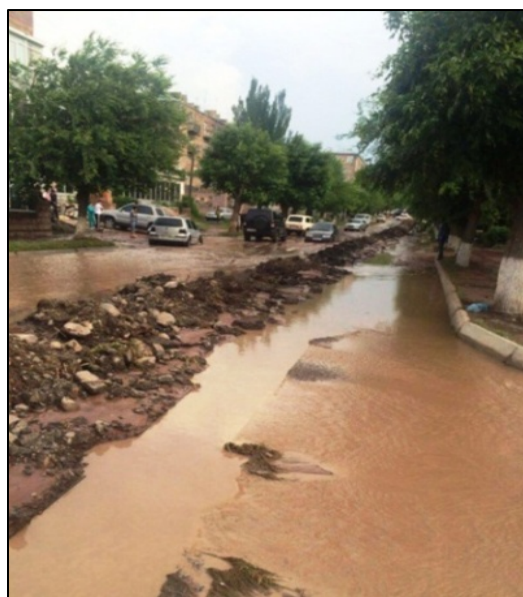
Fig. 3. The site of the city of Artik after the flood peak

In June 2016, powerful streams of water picked up all the garbage, imported soil and brought them down on buildings and vegetable gardens, all livestock was destroyed. According to the Ministry of Emergency Situations of the republic, 120 trucks of stones, mud and silt were removed from the streets of the city of Artik after this mudflow (flood). The thickness of mudflow deposits on the streets of the city was 1.5 m in places. A flood of this force in the Artik is being celebrated for the first time in 200 years.

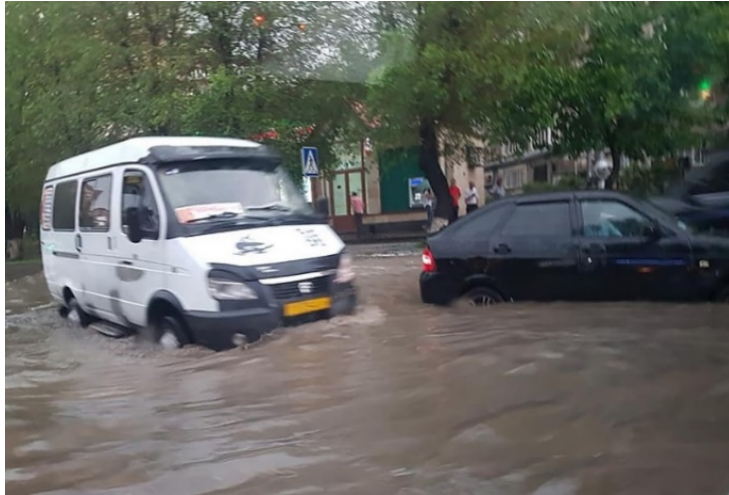
In July 2009, a flood occurred in Avan (one of the districts of Yerevan). The water stream flowing through the streets of the district had a depth of 30-50 cm. The reason for this situation is the clogged drainage hatches with garbage and the low culvert capacity of pipes. A similar flood occurred in Yerevan on July 14, 2017 (see Fig. 4).

Fig. 4. The situation after a downpour on July 14, 2017 in Malatia (South district of Yerevan).

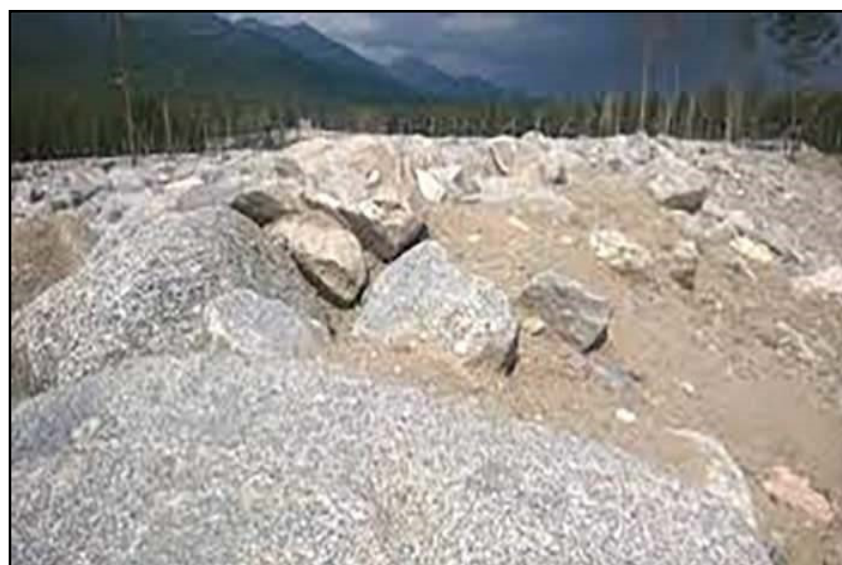
A real mudflow formed on the railway stretch of Alaverdi-Akhtala on the night of June 7, 2023 after heavy rains that lasted for several days. Mud-stone soil blocked the railway tracks on a 100m section (www.panorama.am.news.2023/06/07) (see Fig. 5).

Fig. 5. Mud-stone mass that blocked the railway tracks on the Alaverdi-Akhtala stretch
